PROPOSED DEVELOPMENT KANDOS MUSEUM

TRAFFIC ASSESSMENT REPORT

05 DECEMBER 2023

REFERENCE: TX17440.00-01.RPT.JD-REV0

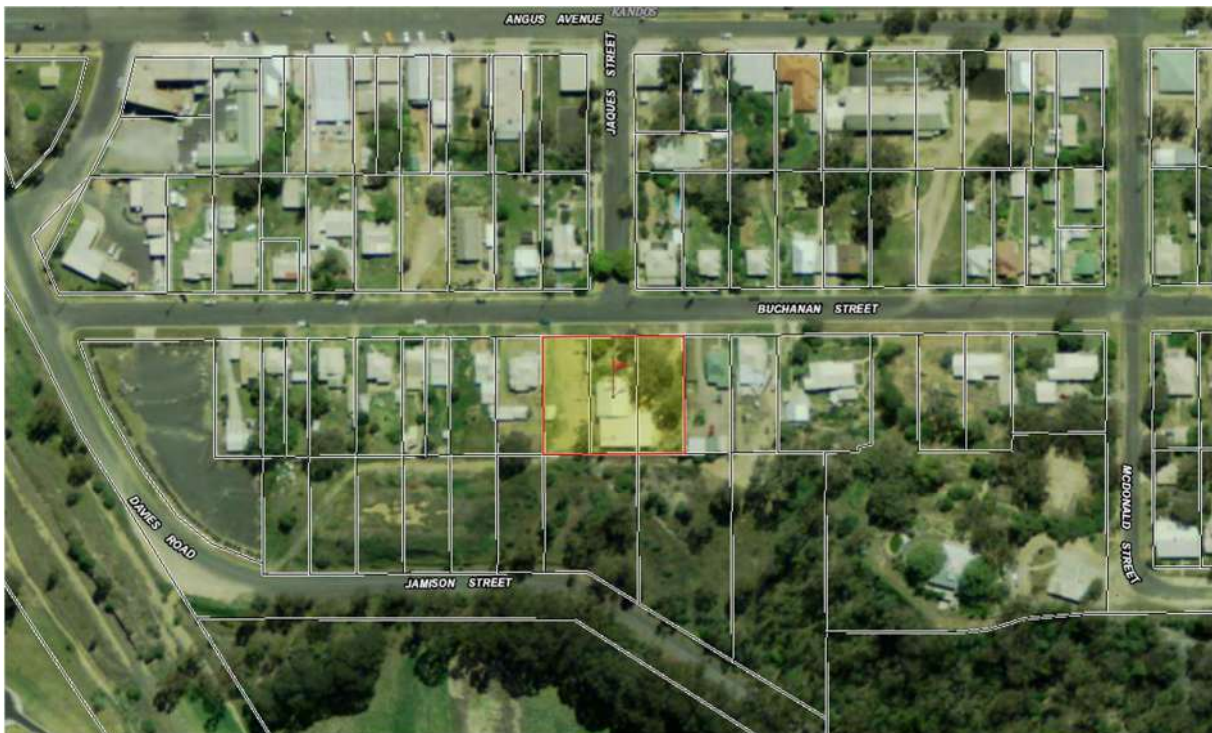
Figure 1: Existing Site

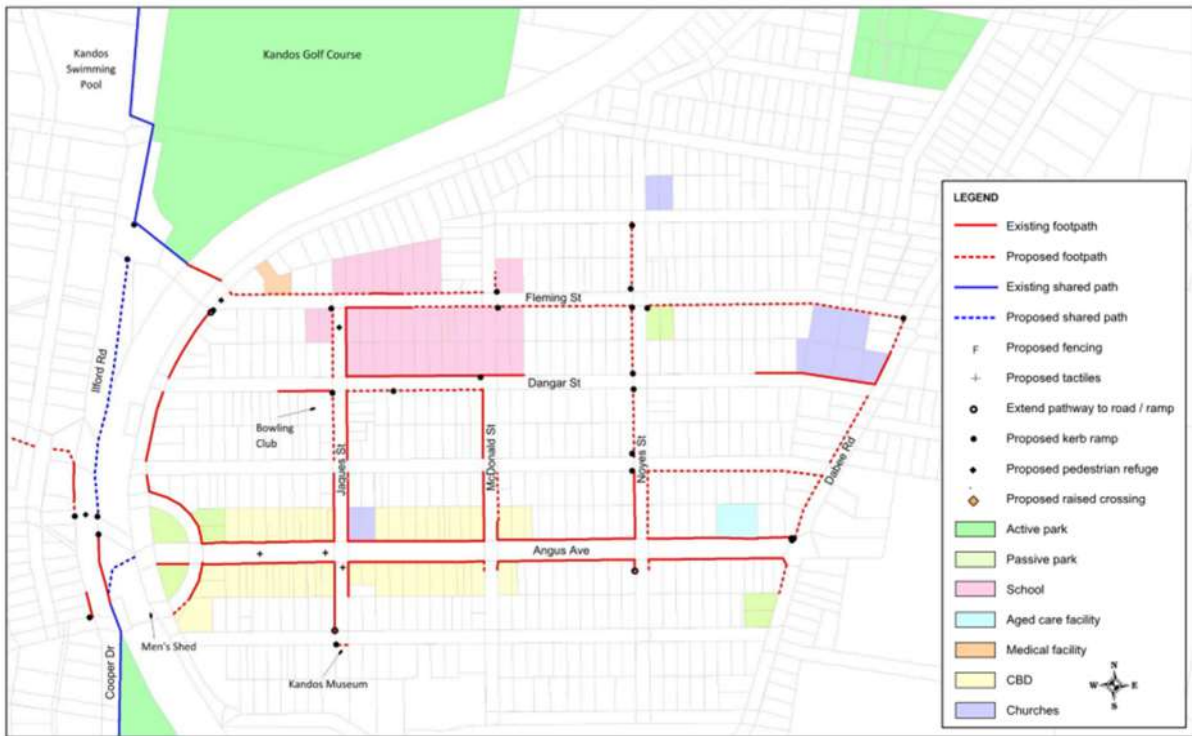
FIGURE D1-2: KANDOS PAMP PROJECT MAP

Figure 4: Kandos Footpaths as shown in the PAMP with proposed footpath and kerb ramp in front of the Museum frontage on Buchanan Street.

A proposed footpath upgrade is shown in the PAMP for the street frontage of the Kandos Museum, as shown in the image below. As yet this upgrade has not been completed.

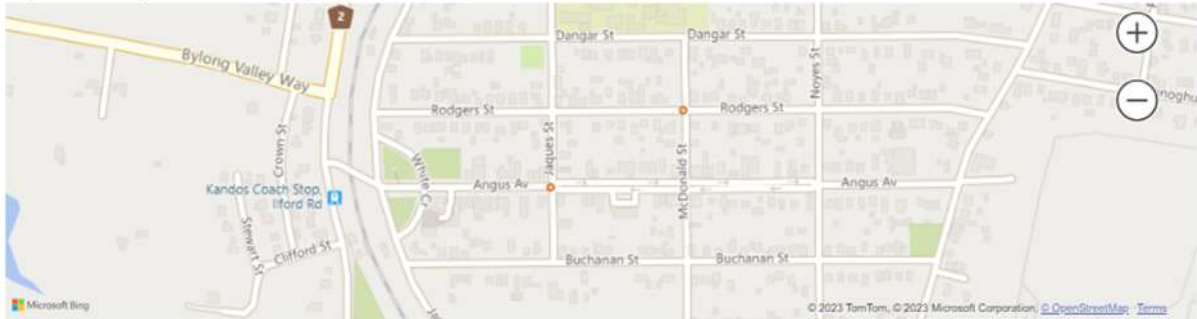
Figure 4: Crash data near the site showing 2 crashes from 2018-2023.

A review of the available crash data from the 5-year period 2018 – 2023 shows that there were 2 vehicle crashes during this period. The location of these crashes is shown in Figure 4 below.

- 1 crash at intersection of Angus Avenue and Jaques St – Serious Injury (2018).
- 1 crash at Rogers Street and McDonald St – Serious Injury (2021).

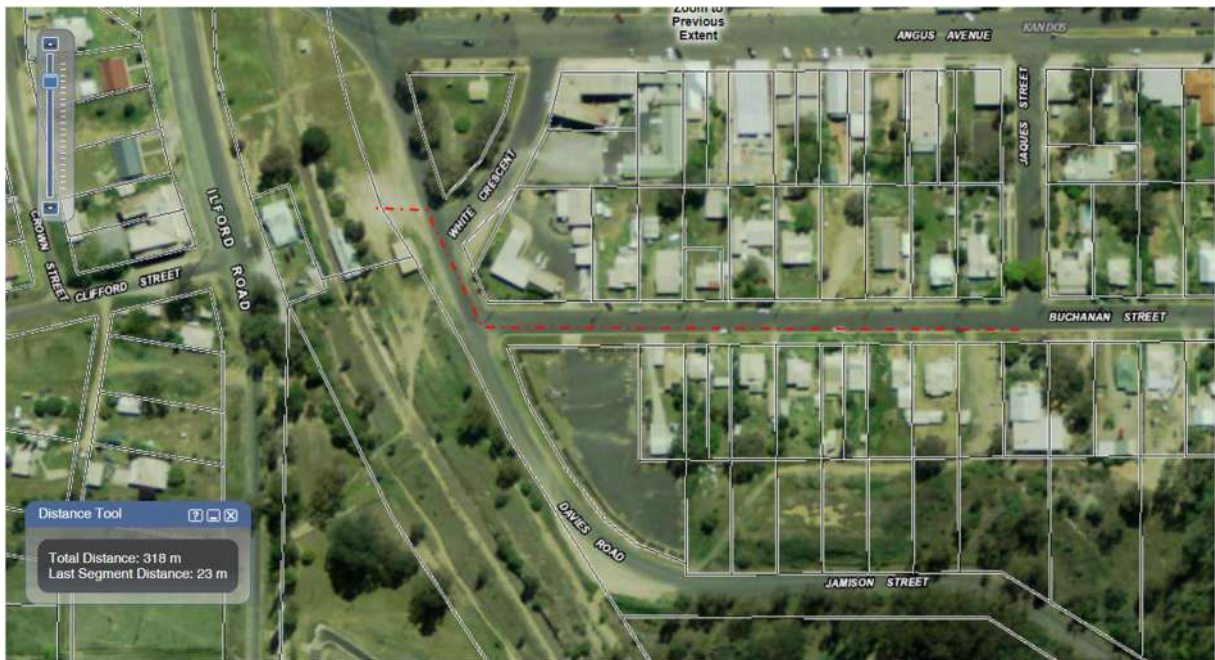
Figure 5: Bus travel total 318m to appropriate parking area located at Kandos Railway Station.

- Large Groups.
 - Large visiting groups such as educational or community organisations will arrive by bus. The bus unloading and loading will be at the site frontage. Operational control will be provided by the Kandos Museum to ensure safe unloading and loading of passengers.
 - Busses will not park on the street frontage. After passengers have departed, the busses will be directed towards the Kandos Railway Station parking lot, approximately 320m away as shown in the image below.

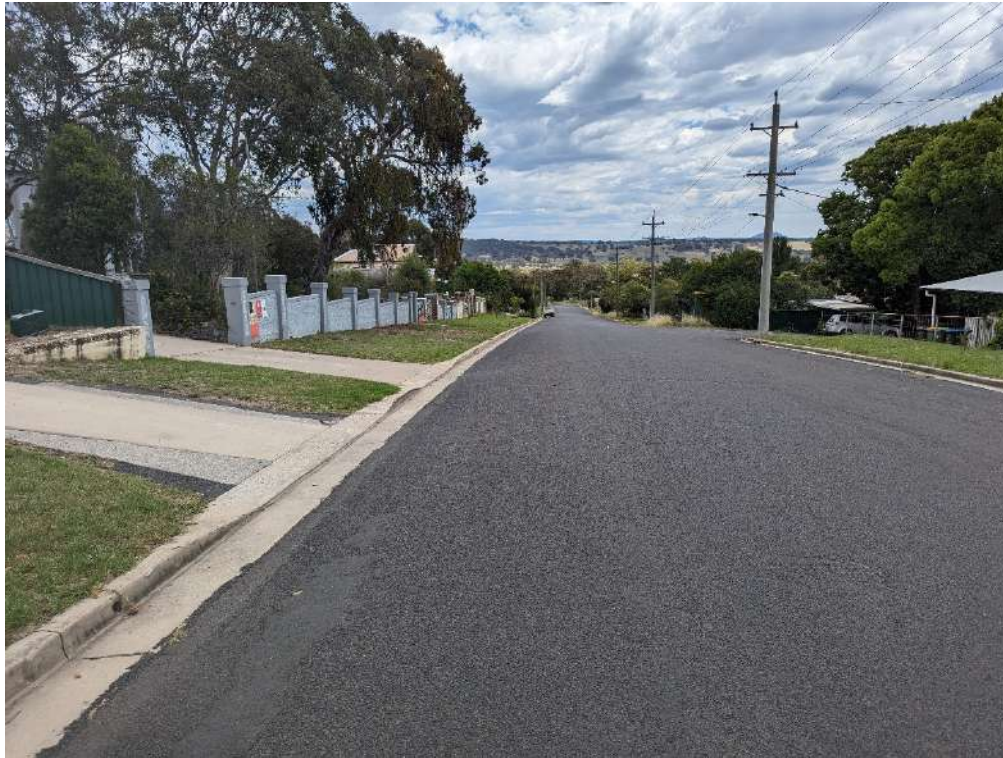
Photo 1
Buchanan Street at Southern end of Kandos Museum site

Buchanan Street is currently constructed as a two way road with an on-road kerbside parallel parking lane on either side. Kerb and gutter (upright barrier kerb) is constructed either side.

Site investigations conducted by Triaxial confirmed the pavement width is 9m wide.

Refer Photos 1 – 4 Appendix A

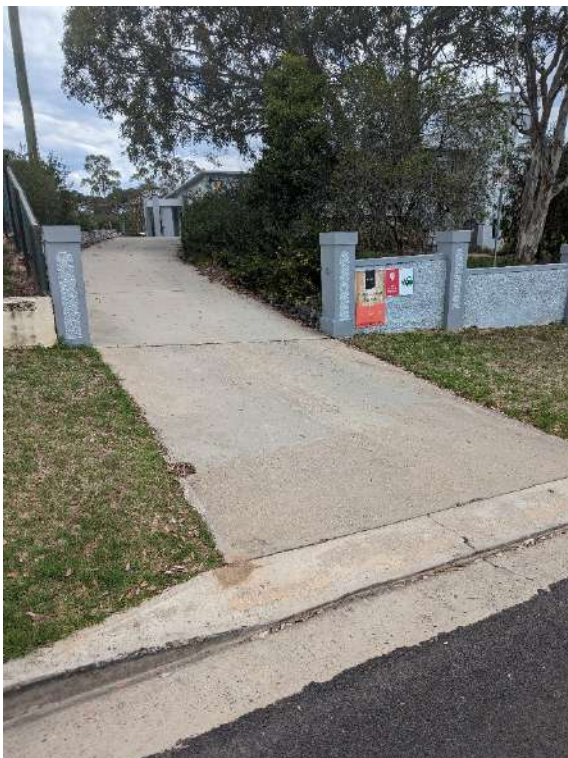
Photo 2
Access to existing car parking area from
Buchanan Street

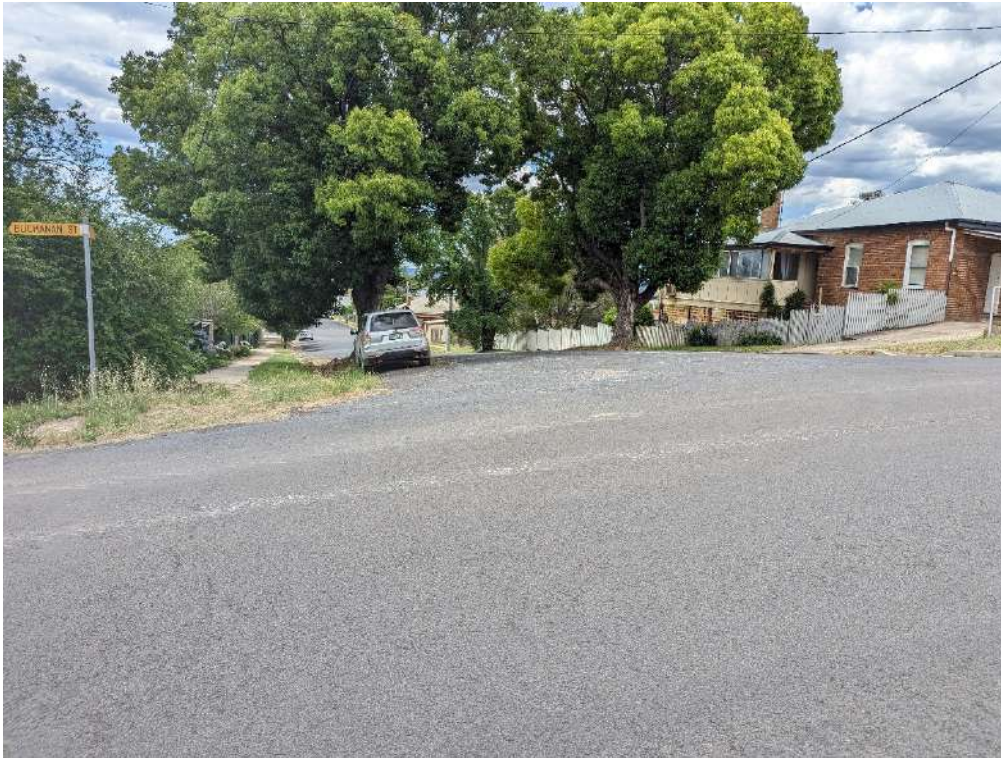
Photo 3

View from Museum frontage looking East towards Jaques Street

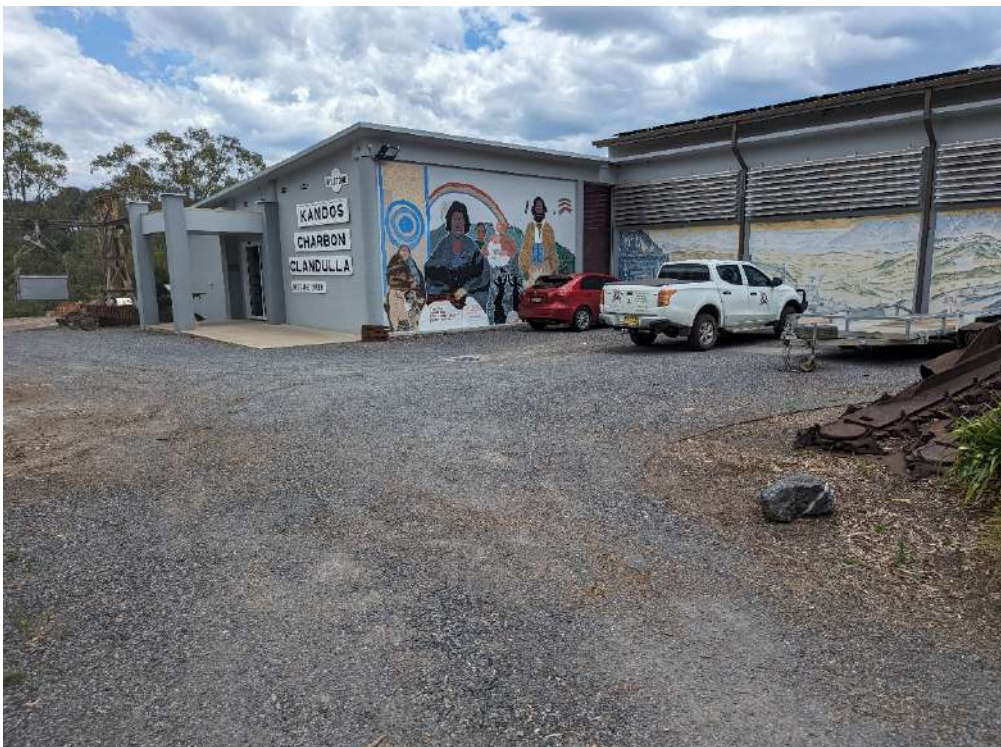
Photo 4

Part of existing museum parking area
